# The Northern Pacific Railway Bridge at Bismarck

by Edward C. Murphy

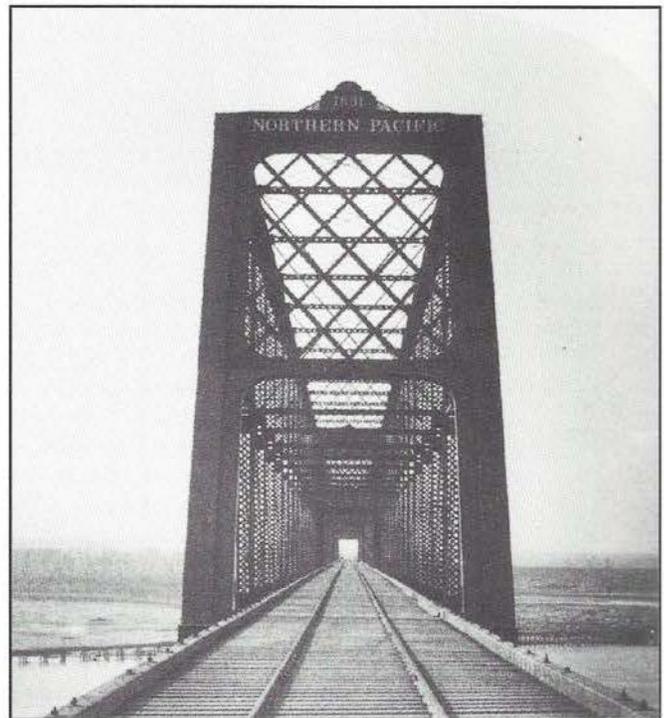
*Photo of recently completed Northern Pacific Railway bridge, looking west through the east end of the bridge. This photo likely taken by F. Jay Haynes in 1882 or 1883.*

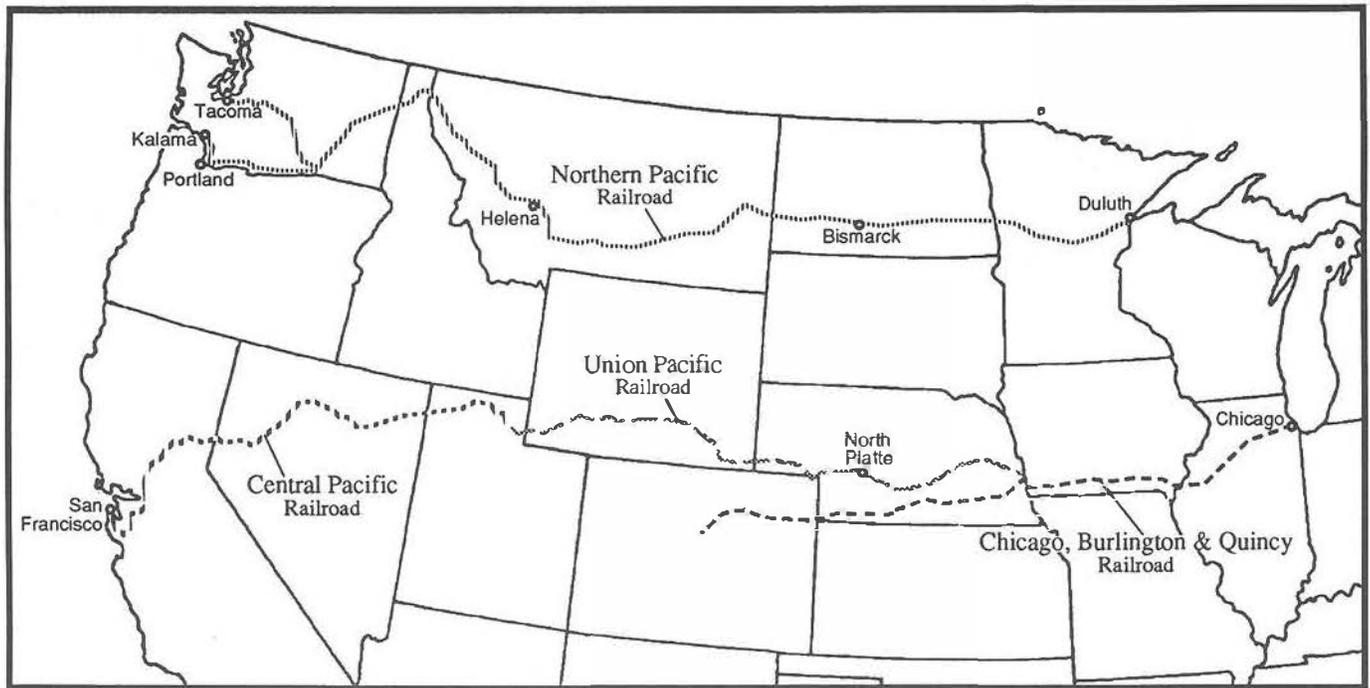
The routes of the northern and central transcontinental railways. On May 10, 1869, the westbound Union Pacific Railway met the eastbound tracks of the Central Pacific to complete the first transcontinental railway at Promontory Point, Utah. The northern route would not be completed by the Northern Pacific Railway until 1883 near Gold Creek, Montana. The central route took six years to construct, while the northern route took twelve years. Map by Brian R. Austin.

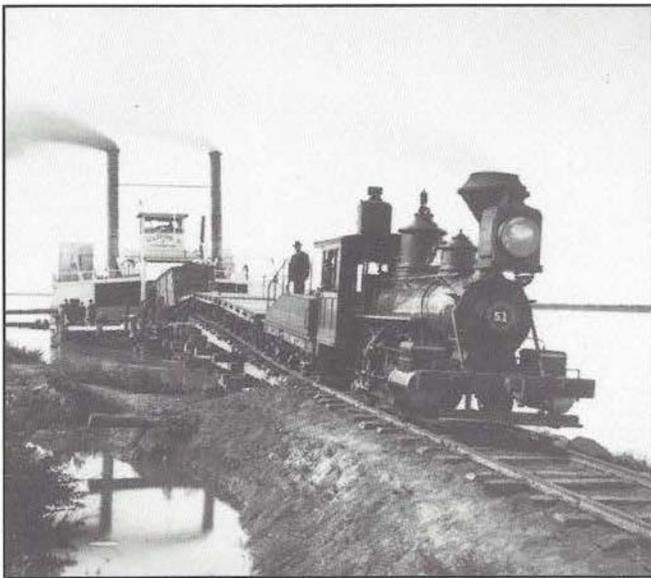
population in the territories.<sup>10</sup>

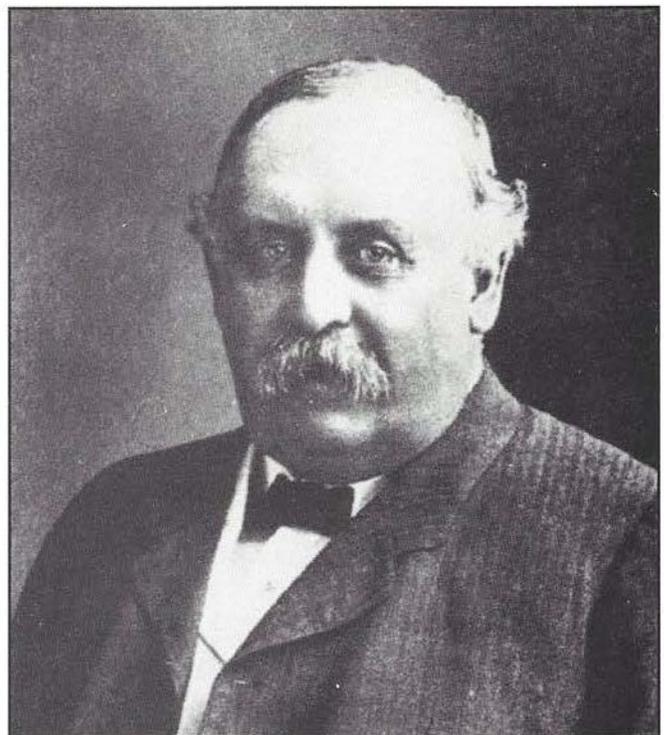
*George Shattuck Morison (1842-1903), one of the country's greatest and most respected engineers, designed and supervised the construction of the Northern Pacific Railway Bridge at Bismarck.*

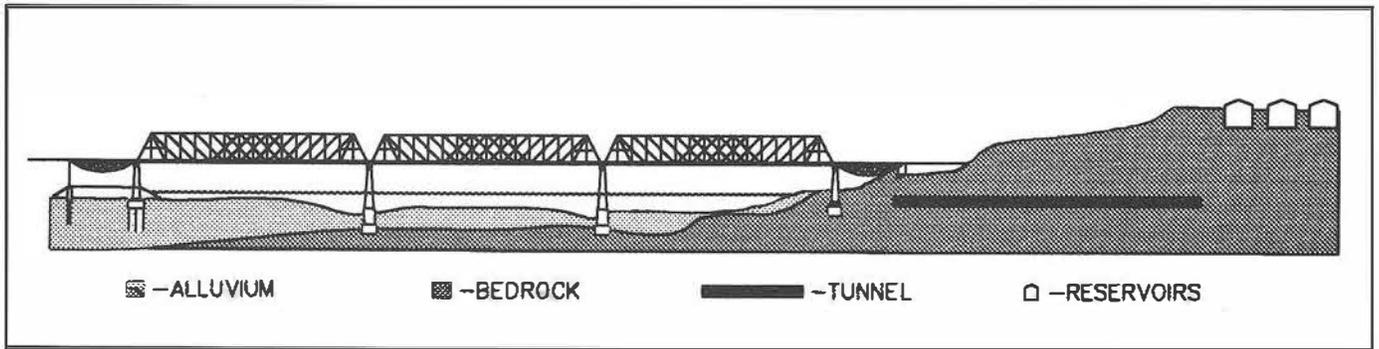
21. Archibald Black, *The Story of Bridges* (New York: Whittlesey House, 1936), p. 82.

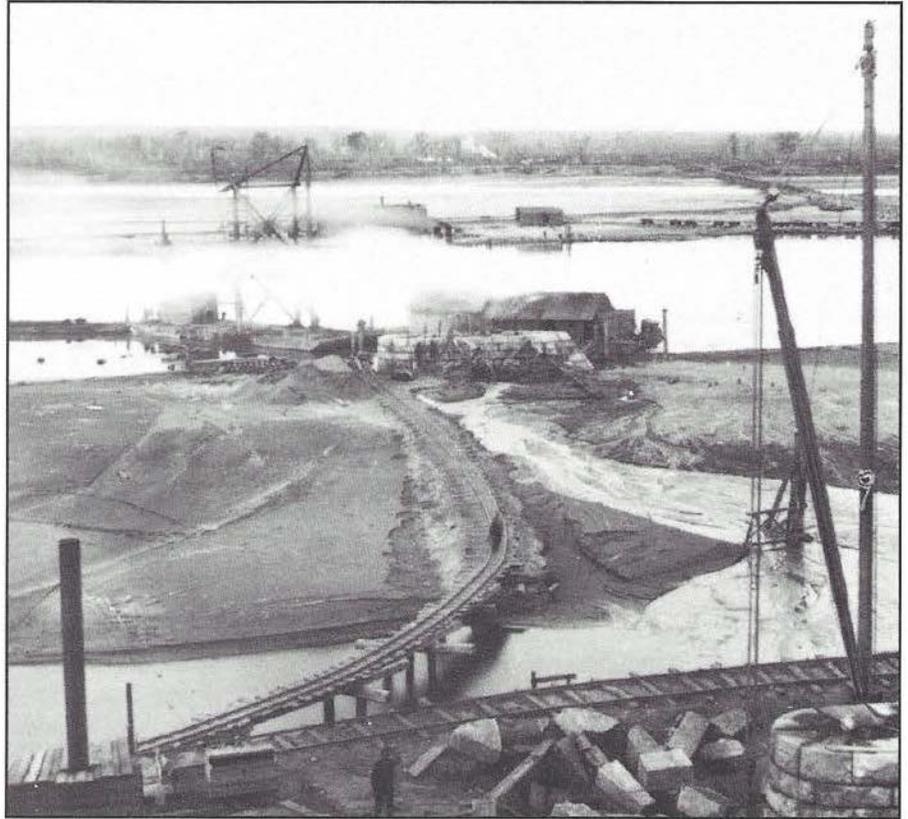
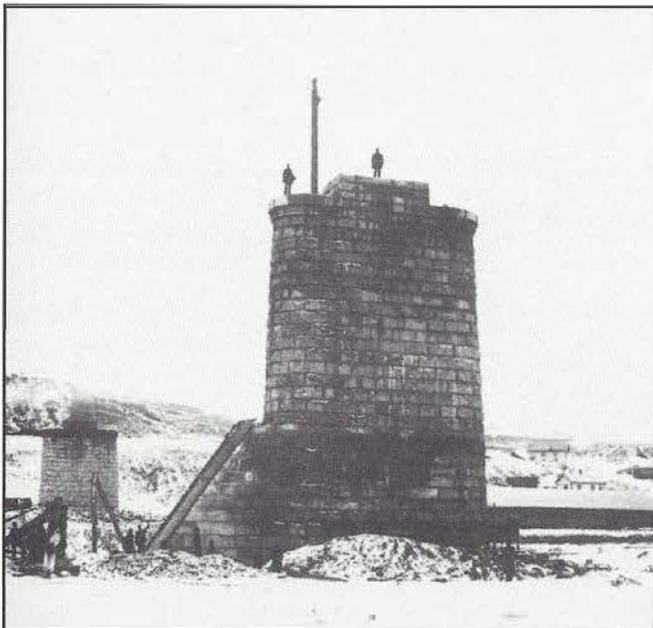
Left: Workers add the finishing touches on pier 2 by attaching the steel nosing plate; a completed pier 1 (furthest east) stands in the background. The base of the pier 2 caisson is approximately forty-six feet below the surface. Photo by F. Jay Haynes in February 1882. Courtesy of Haynes Foundation Collection, Montana Historical Society, Helena, Montana.

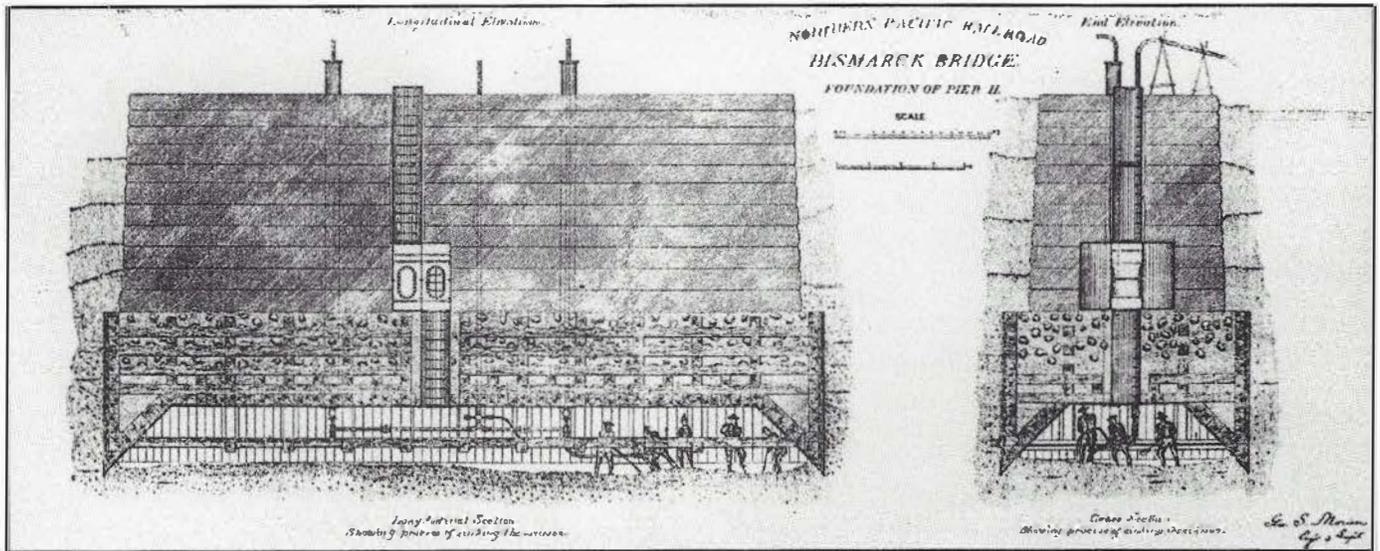
Morison's drawings of the front and side view of the base of pier 2 and its underlying caisson. Men are shown removing sand from the base of the caisson floor with pumps which sucked the soft Missouri River sand from beneath the caisson and expelled it at the surface, thus enabling the caisson to sink under its own weight. The intake and outtake lines as well as the air-lock chamber are depicted on the drawings. Morison's drawings depict pier 2 at approximately one-fourth of its final height.

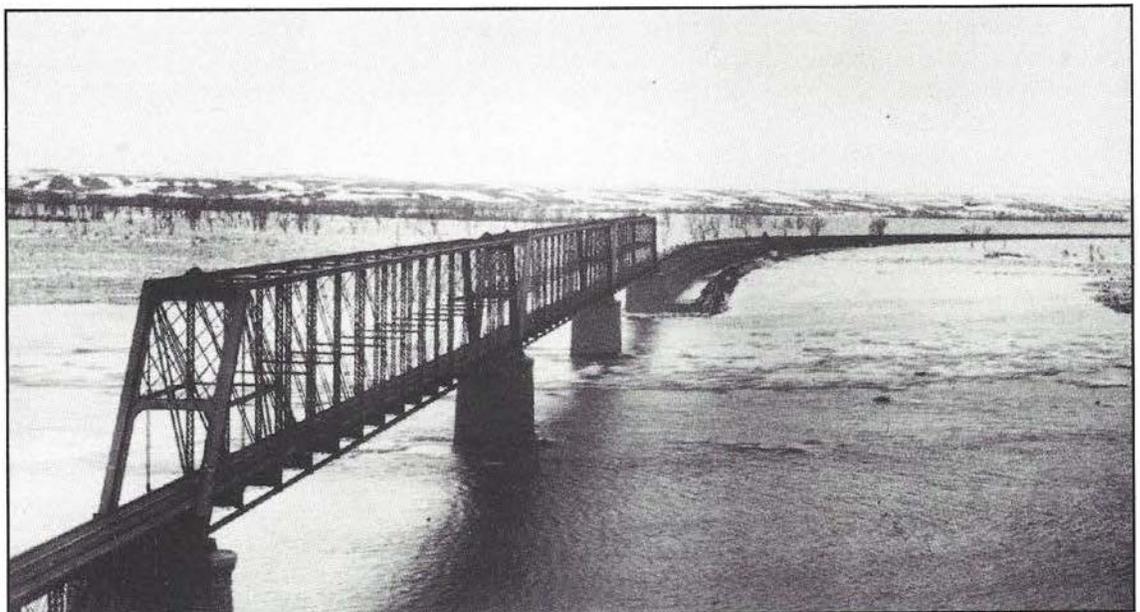
longer visible. Slabs and pieces of both Watab and Rock Island granite litter the area below pier 1. A number of slabs are also present on the hillside above the water treatment plant and mark the area used by Morison to unload the construction material as it arrived by rail.

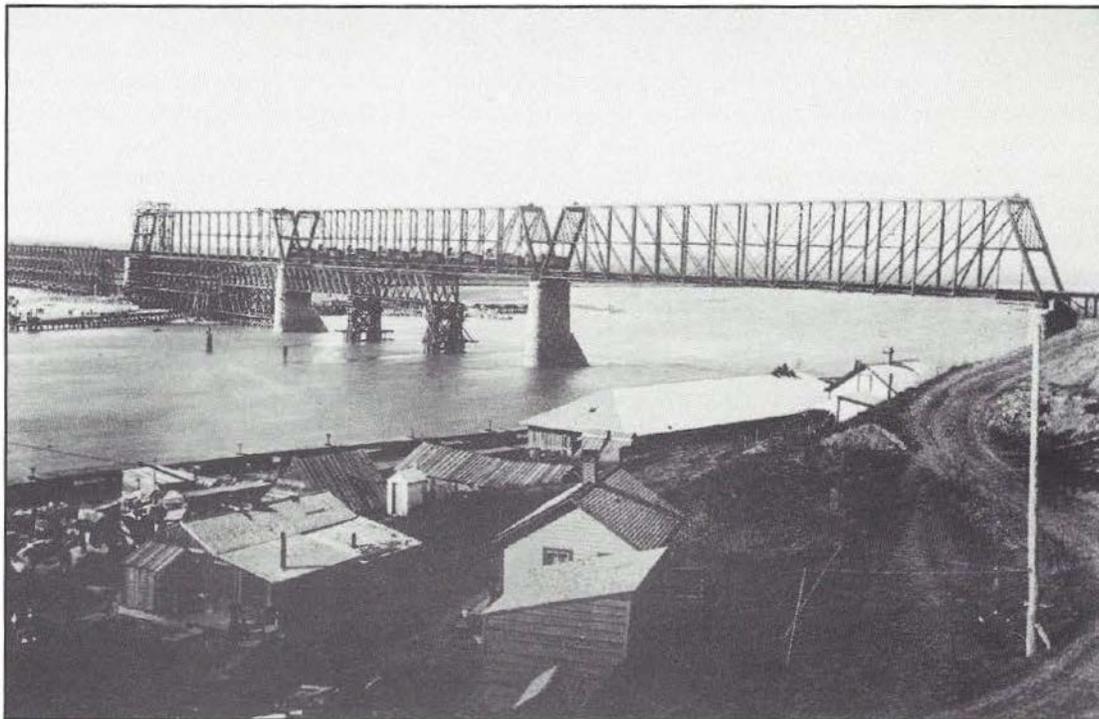
*Official testing of the Northern Pacific Bridge by a committee of engineers on October 21, 1882. The crib work was to be removed shortly after this photo was taken but much of the base filled in with sand and could not be removed. It was subsequently swept away from the bridge during the next spring breakup of ice. An area of the river was left open between two of the piers during construction to allow steamships to navigate. The wooden trestle on the west approach (left) was eventually filled in with dirt.*

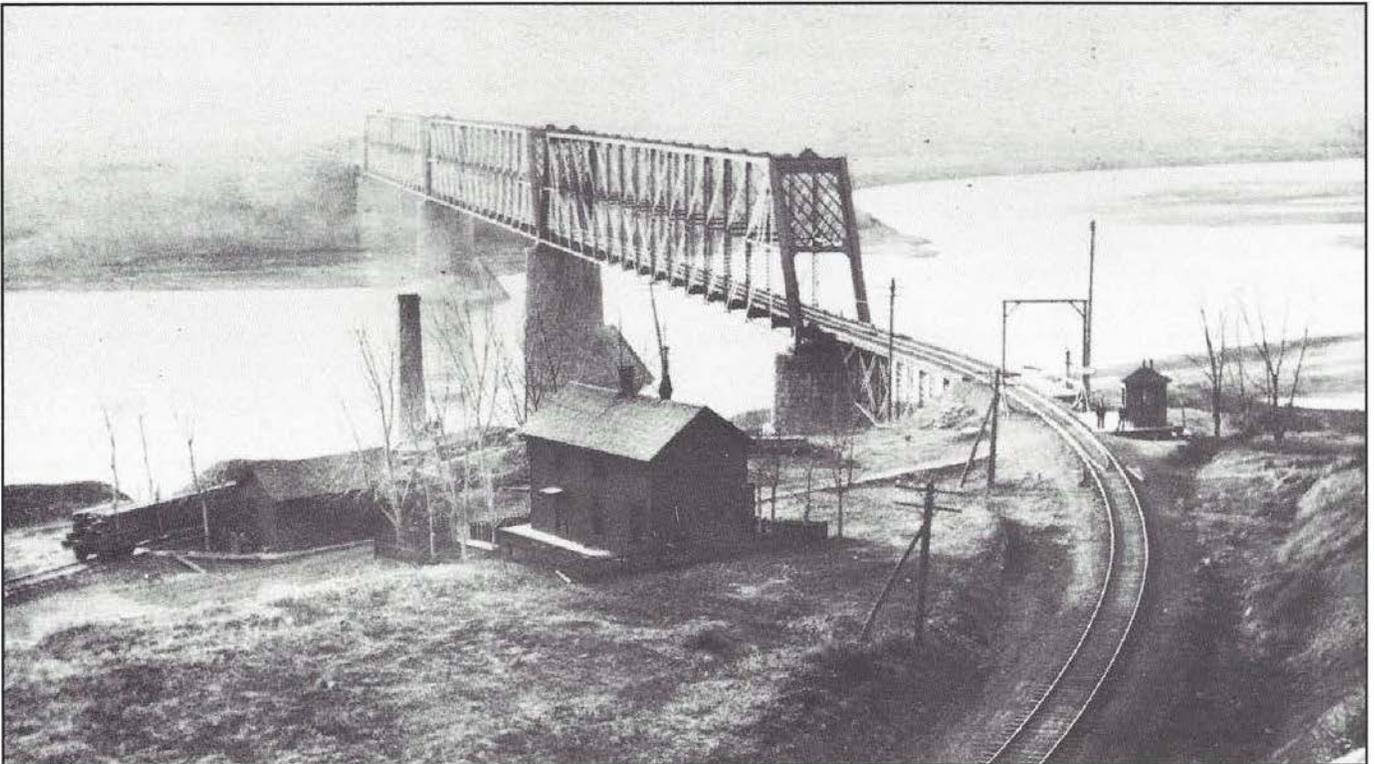
*The Northern Pacific Railway Company posted a watchman at the east end of the bridge from its completion in 1883 until the replacement of its spans in 1905. The watchman's shack is on the right side of the track and his house is on the left side. Below the house are a toolshed and the pumphouse for the Bismarck Water Company. As designed by Morison, the tracks took a sharp turn before entering the east side of the bridge. In 1951 the Northern Pacific reduced the curvature in this area by making a deep cut into the hillside east of the bridge and rerouting the tracks. This reportedly made it much easier for large locomotives to negotiate this curve. Photo ca. 1890s.*

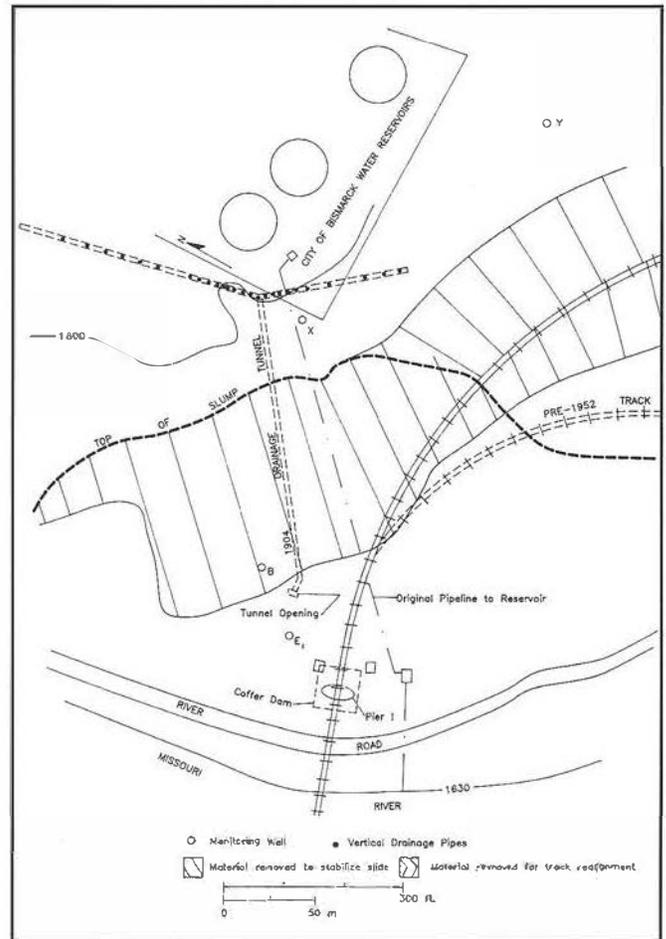
In 1904 a drainage tunnel, which branched in two directions below the reservoirs, was constructed to stabilize the area by intercepting water leaking from the Bismarck Water Company reservoirs. Construction of the tunnel began in January and was completed late in the summer. Little water was accumulated in the tunnel so numerous boreholes were drilled down from the surface into the tunnel to assist with the drainage. This map was modified from Peck's report.

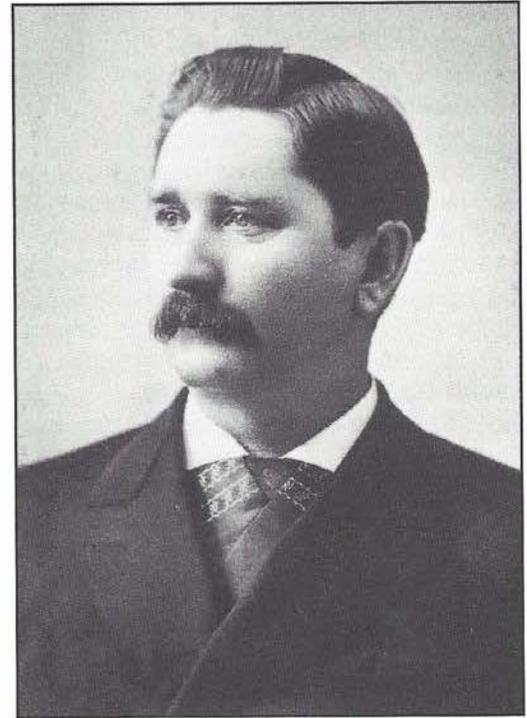
Alexander  
McKenzie,  
1886

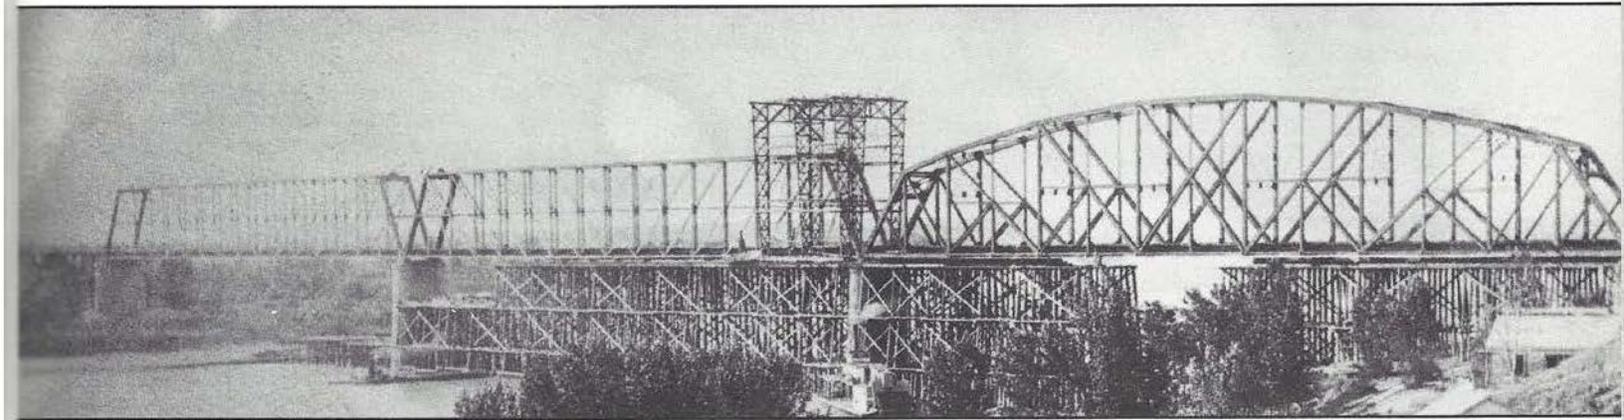
Hughes as secretary. On May 23, 1896, a judgment was made in District Court requiring the Bismarck Water Company and Central Trust Company of New York to sell the waterworks to the highest bidder. The plaintiffs in this case were Alexander McKenzie, George

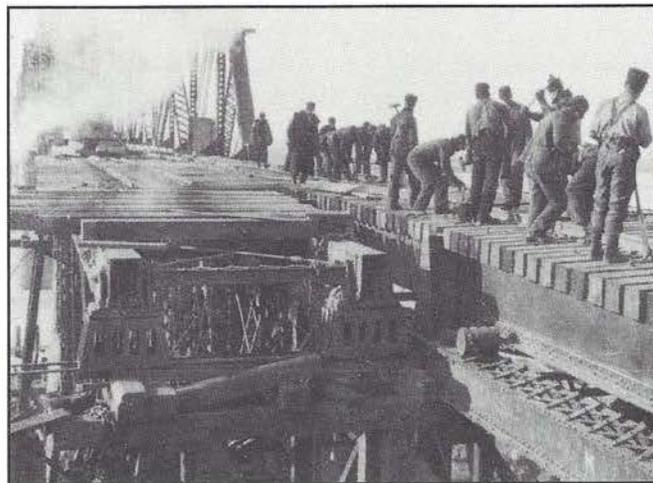
A. Hughes, and Eber H. Bly. According to an article in the April 23, 1896 issue of the *Bismarck Tribune* the suit was brought to determine the priority of lien, whether local creditors (such as McKenzie et al) should be reimbursed before the Central Trust Company was reimbursed. On December 10, 1897, Ernest N. Morison (presumed to be George Morison's nephew), John S.T. Waters, and Miles White, Jr. purchased the works for \$37,000. On February 9, 1898, Morison, Waters, and White sold the waterworks to the Bismarck Water Supply Company for \$57,250.

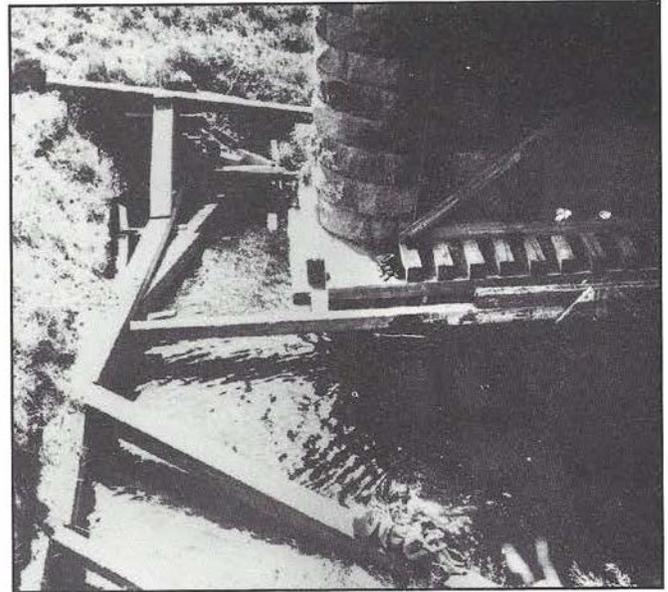
*In 1918 a cofferdam, consisting of a large pit, braced with thick timbers, and excavated down to the base of the foundation, was placed around pier 1 to protect it from the sliding hillside. The cofferdam succeeded in slowing movement on the pier but had to undergo major repairs in 1923 and again in 1940 due to damage caused by pressures placed on it by the landslide. The cofferdam periodically filled with water and was a favorite swimming hole for area youth.*
